**TRANSMITTAL
ASSESSMENT OF DAM SAFETY OF
COAL COMBUSTION SURFACE IMPOUNDMENTS
DRAFT INSPECTION REPORT
SITE 30 (BRUCE MANSFIELD)**

DAM SAFETY INSPECTION NOTICE

DEP Office	SWRO- PITTSBURGH	Phone	4124424000	Dam Permit or ID. #	D04-049
Address	400 WATERFRONT DR BH PA 15222			Dam or Project Name	LITTLE BLUE RUN
Owner or Permittee	FIRST ENERGY GENERATION CORPORATION			County	BEAVER
Complete Mailing Address	BRUCE MANFIELD PLANT PO Box 128 SHIPPINGPORT PA 15077-0128			Municipality	GREENE TOWNSHIP
				Take GPS readings at the center of the crest of the dam.	
				Latitude:	40° 37' 40.14" N
				Longitude:	80° 30' 47.79" W

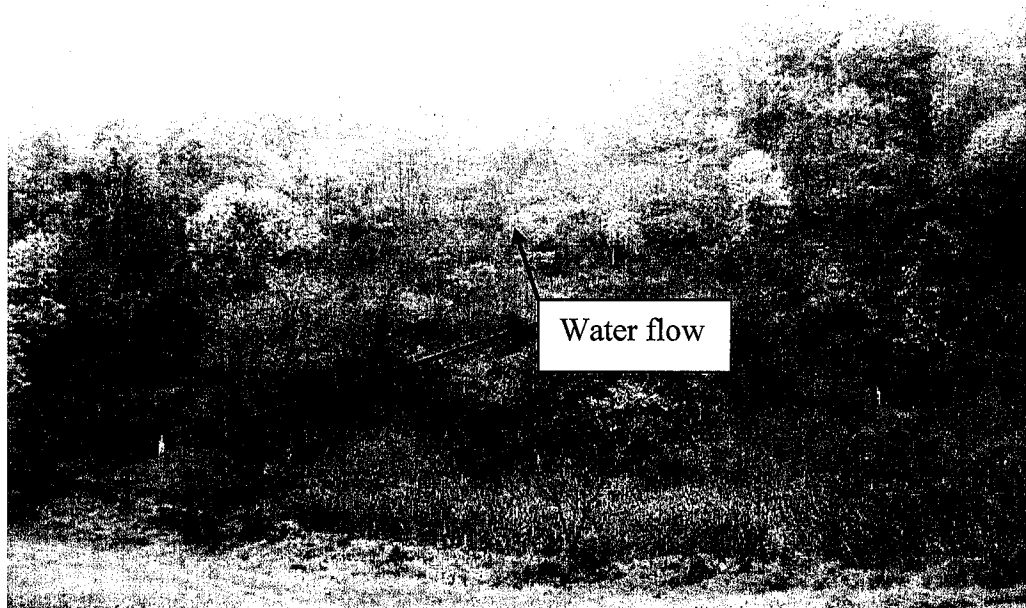
left abutment

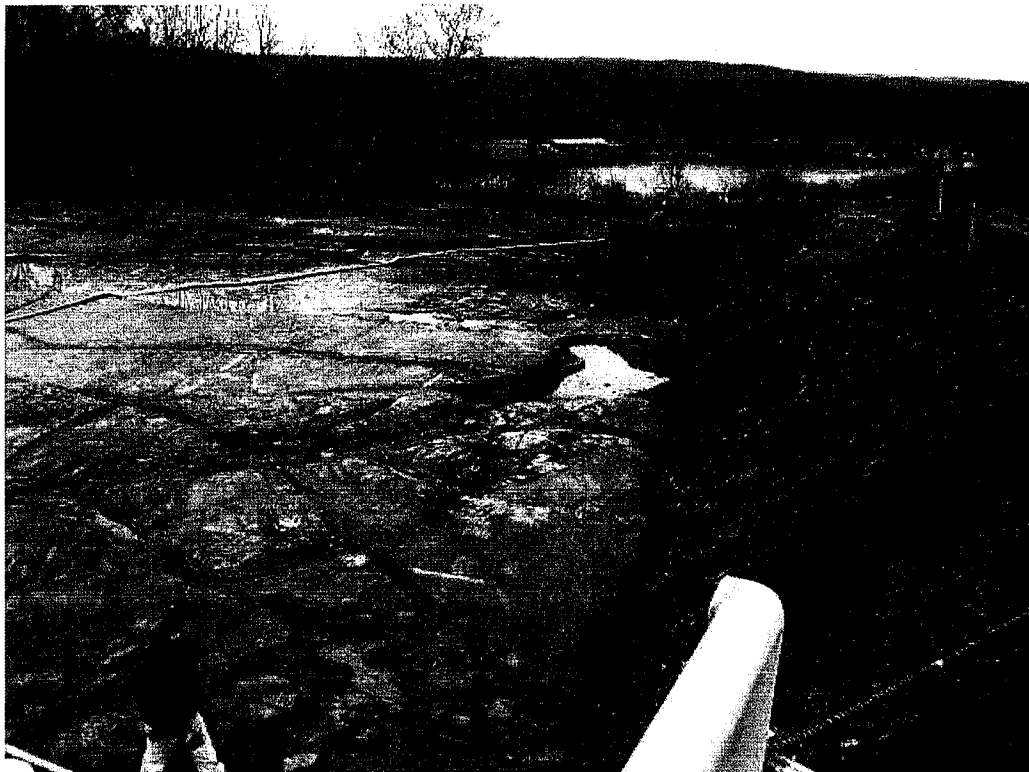
DS of weir from right – showing joints in the abutment

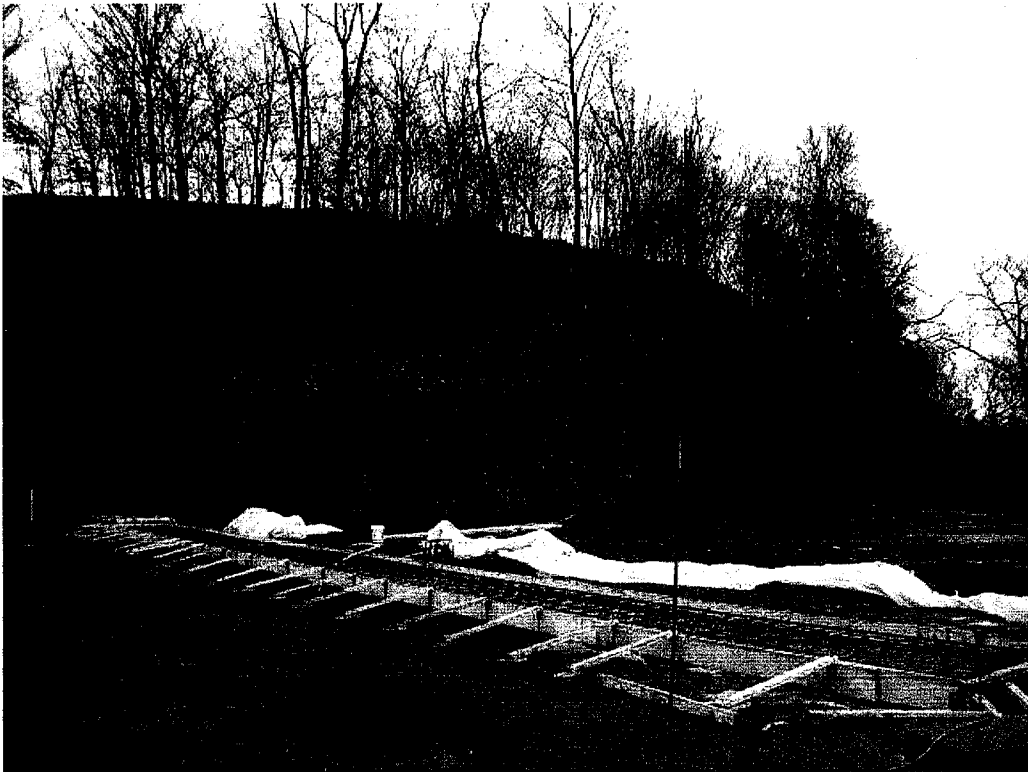
d04-049 11/20/06 rock vertical joint structure on left abutment

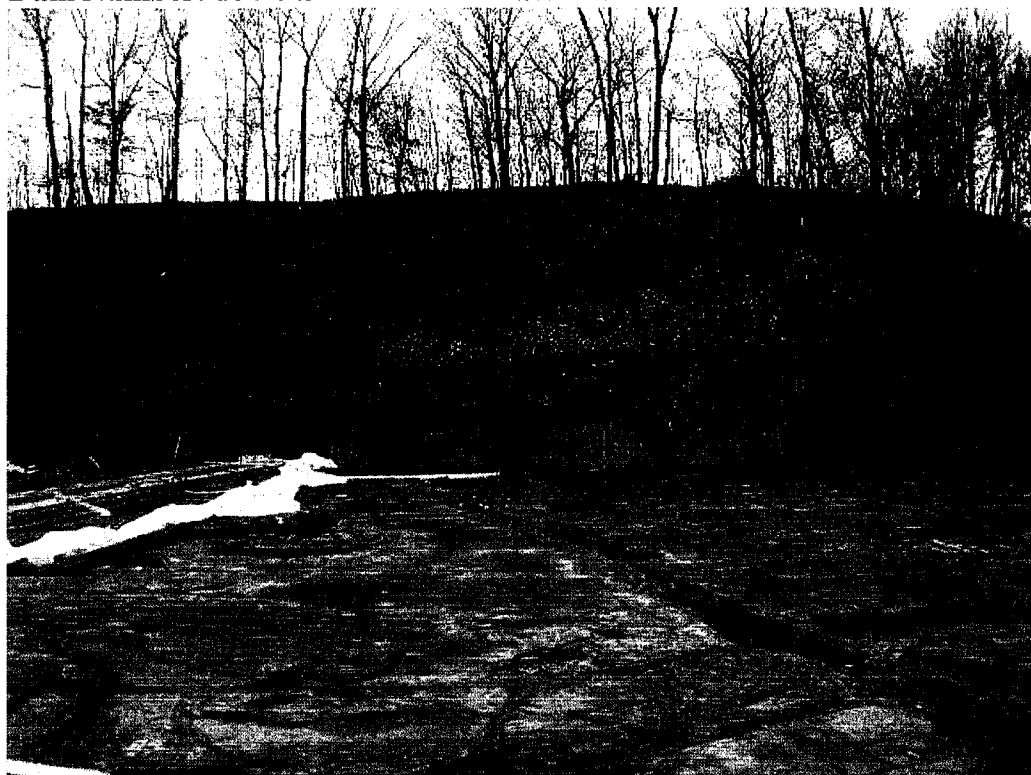
rock floor joints & left abutment joints

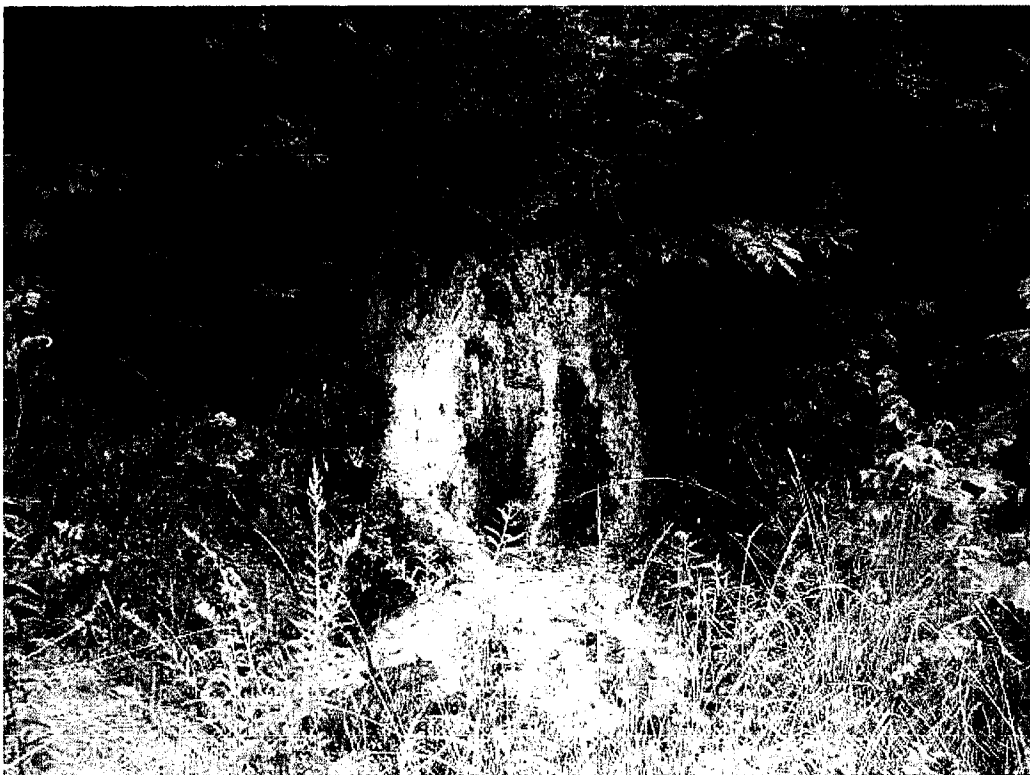
seep at el 930 on right abutment

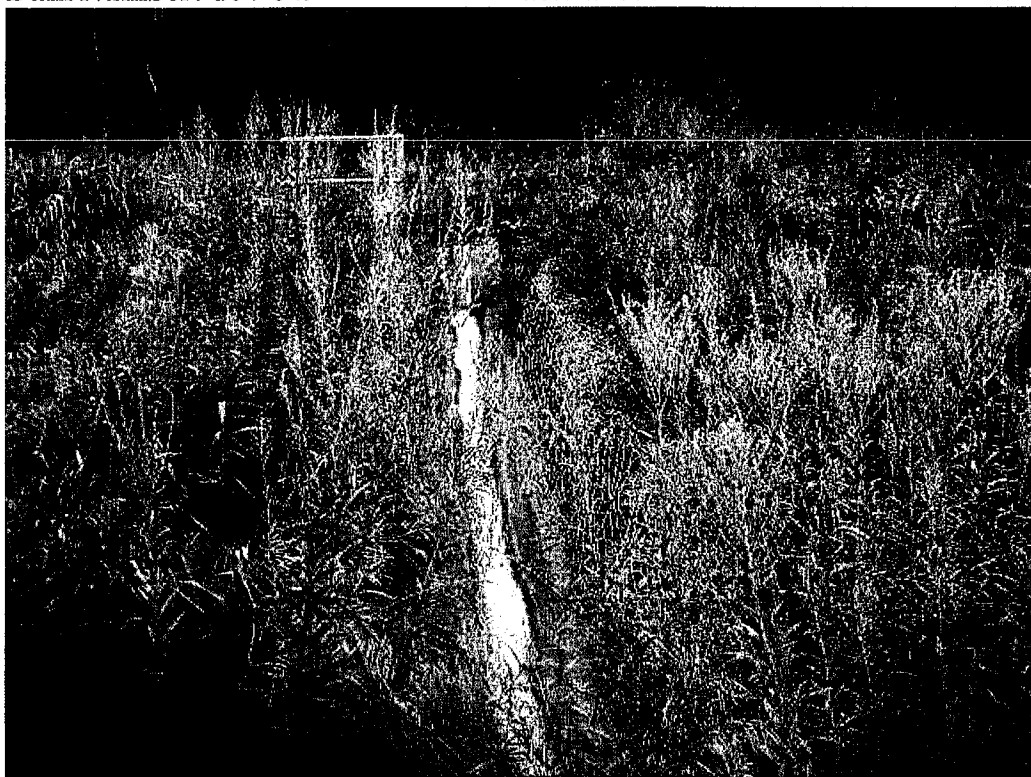
discharge of seepage from right abutment

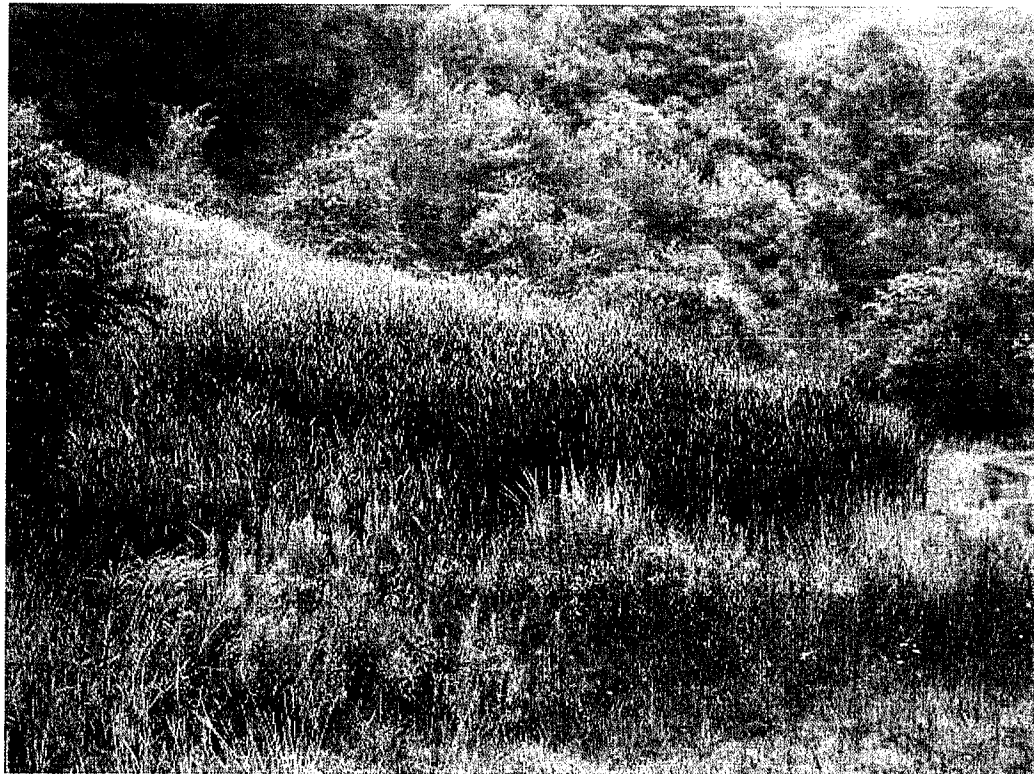
wetland growth on left abutment

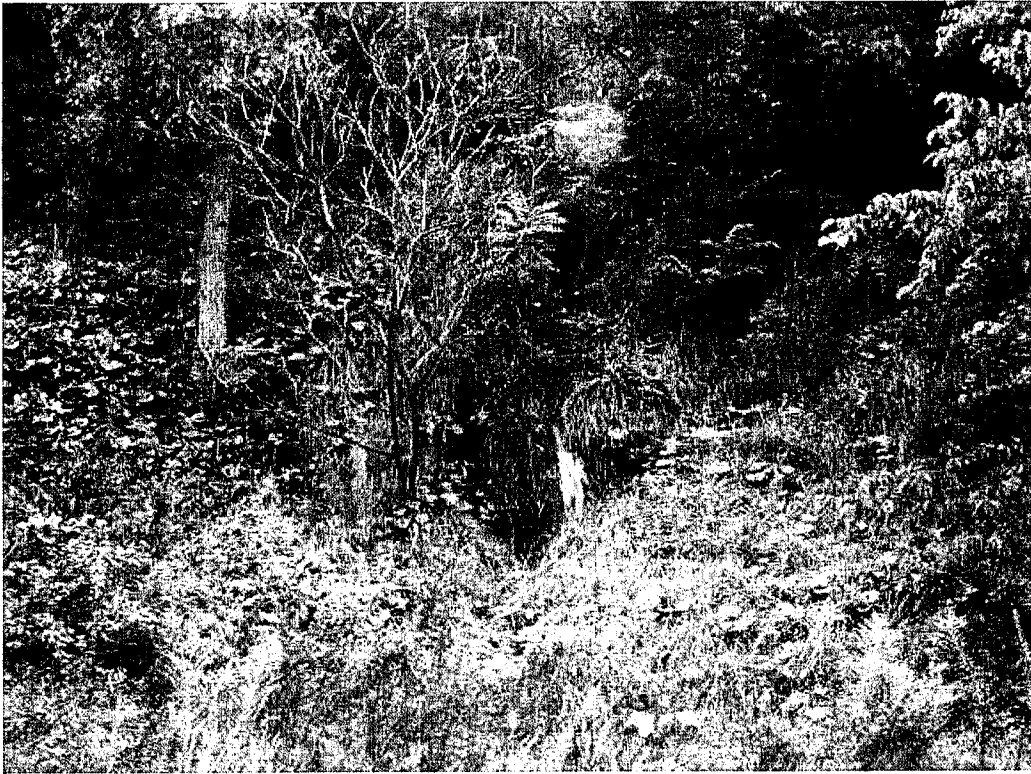
close-up of left abutment discharge

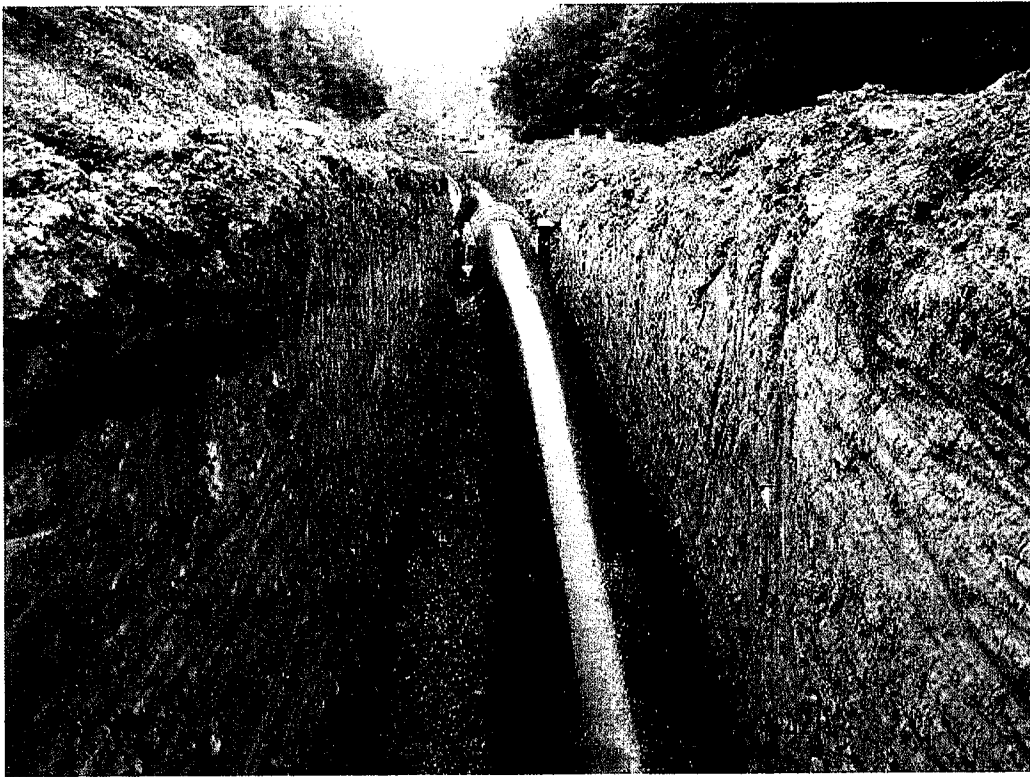
soil cut on right side of abutment
